5"/54 PROJECTILES TYPE EX 23 MOD 1; TEST OF

RECOVERY FIRING OF 5"/54 PROJECTILES
TYPE EX 23 MOD I IN A WORN GUN

NPG REPORT NO. 1064

Recovery Firing of 5"/54 Projectiles
Type EX 23 Mod 1 in a Worn Gun

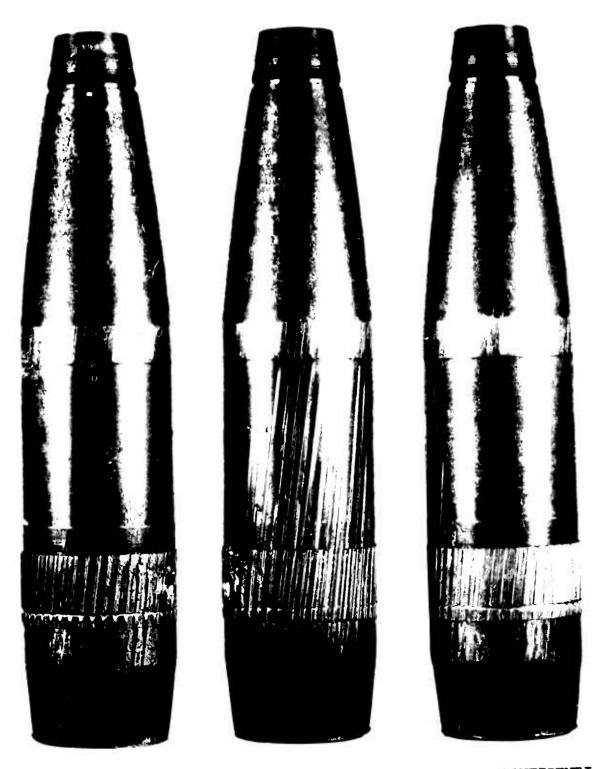
NP9-49160

Body engraving and partial failure of the bands occurred on rounds 2 and 3. Round 1 (warming round) did not body engrave.

The velocity and spin were uniform, but the attainment of full spin can probably be attributed to the fact that the projectiles body-engraved. The pressure variations shown are considered normal for this type of powder under these conditions.

o May 1952 CONFIDENTIAL SECURITY INFORMATION
Three views (120° apart) of Recovered EX 23-1 Projectile
No. 1293, Fired in Gun Mk 18 Mod 1 No. 16064.
Figure 2

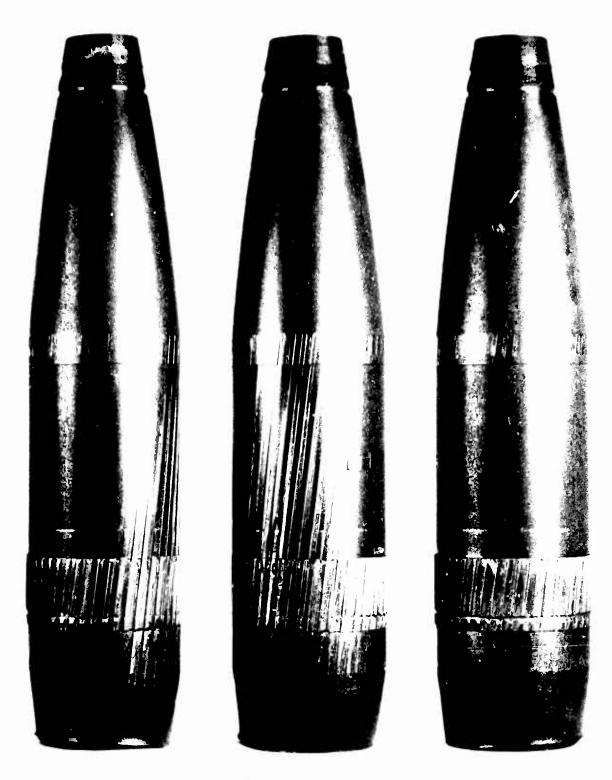
NP9-49161

o May 1952 CONFIDENTIAI
SECURITY INFORMATION
Three Views (120° apart) of Recovered EX 23-1 Projectile
No. 1294, Fired in Gun Mk 18 Mod 1 No. 16064.
Figure 3
